Manhole Inspection Summary

Manhole # S37KK_029MH

Insp Date: **3/19/07 11:24 AM**

Location Address: **1718 LAFEYETTE AVE**

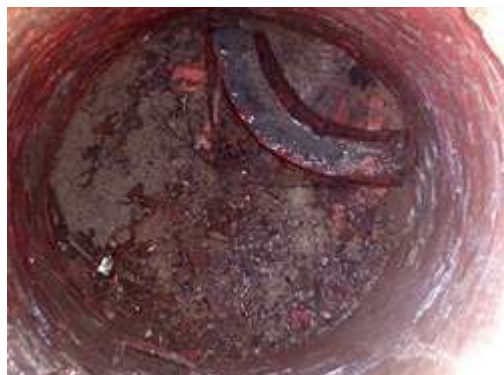
Top View

Corroded steps. Evidence of surcharge - Bench debris. Channel debris.

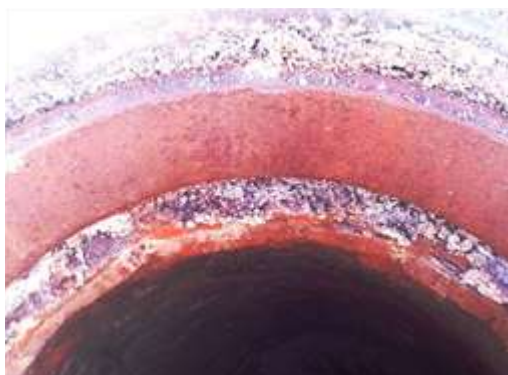
Defect

Frame leaks. Frame offset. Adjustment deterioration and infiltration.

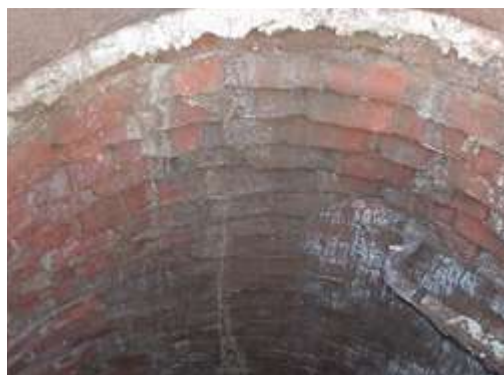
Defect

Frame leaks. Adjustment deterioration and infiltration.

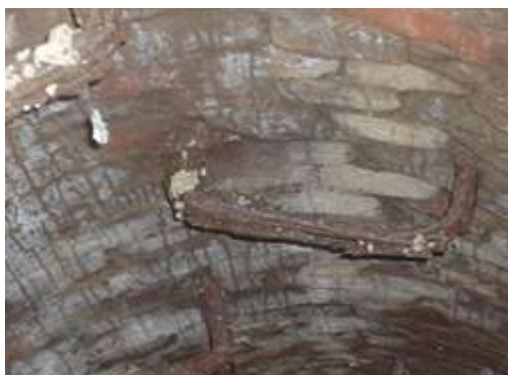
Defect

Adjustment and Barrel infiltration.

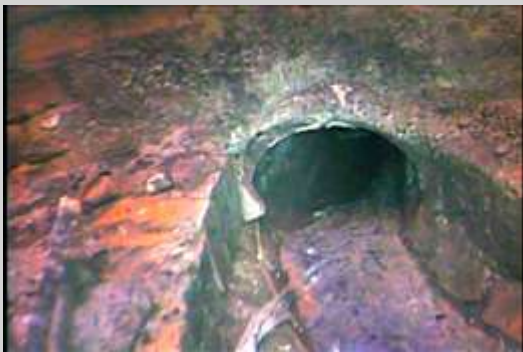
8 in. Circular Gravity Sewer Pipe Out @ 12 O'Clock

Deposits: ☐ None ☒ **Mud** ☐ Sludge ☒ **Debris** ☐ Grease

Silt Depth: **0.5** (in.) Deposits Extent: **Light**
